Study Of Instability Risks On The Eastern Slope Of The Beni-Haroun Dam In Mila Province, Eastern Algeria

Abstract

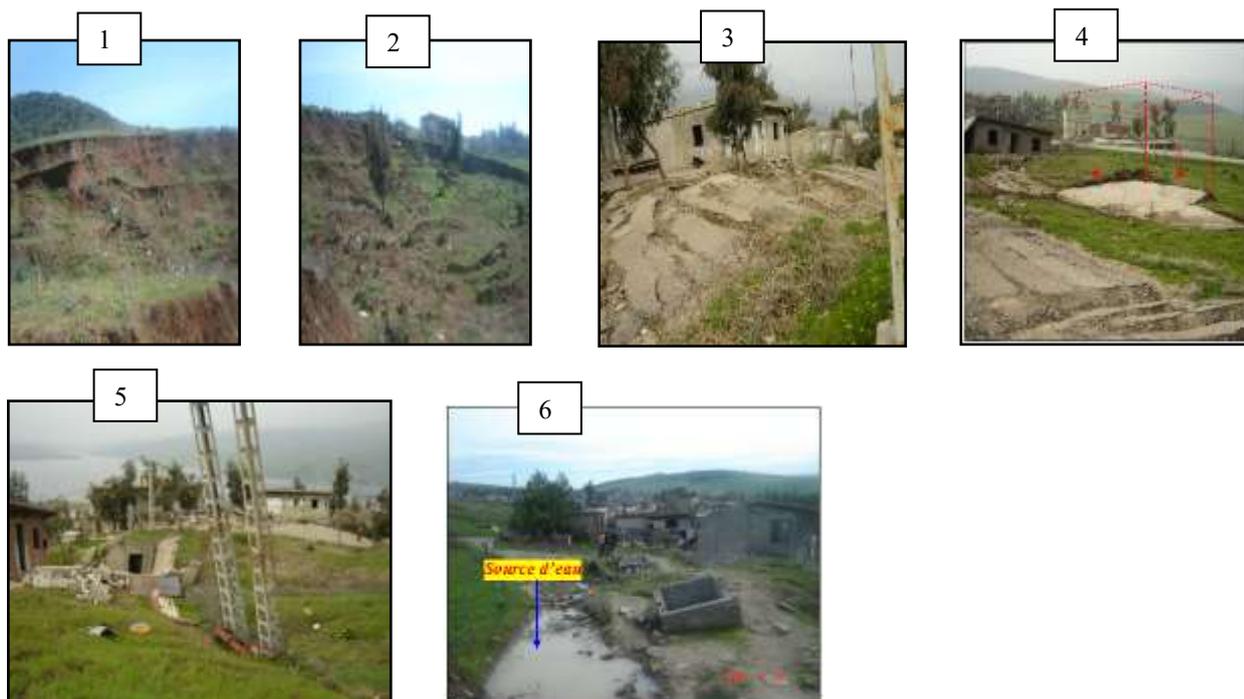
Photos 1 and 2: Detachment niches observed below National Road 27, beneath the ANB base camp.

Photo 3: Tilting of buildings and leaning of certain trees.

Photo 4: Subsidence of a house.

Photo 5: Ruins of a building and leaning of utility poles.

Photo 6: Tilting of a building near a water source.

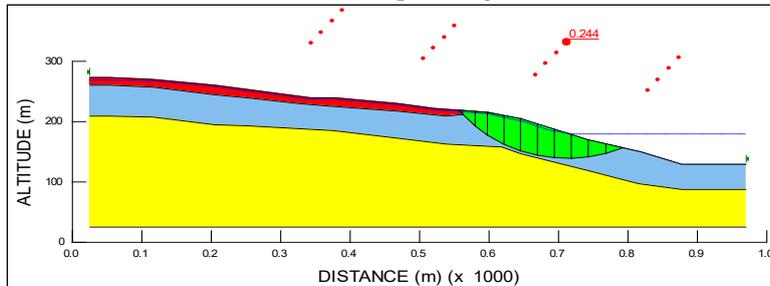
Fig. 5: Critical circle obtained according to Profile 01 (current level of the retaining wall).

The minimum safety factor corresponding to the critical circle was found to be 0.123 for profile 01, 0.366 for profile 02, and 0.135 for profile 03. These values are below the acceptable safety factor threshold of 1.5, confirming the instability of the slope.

- Depth of sliding = 51.72m (current level of the retaining wall).
- Depth of sliding = 41.37m (maximum level of the retaining wall).

The depths of sliding obtained by the software for the three profiles are very close to those obtained by inclinometers. These depths should be taken into consideration during the execution of any reinforcement system.

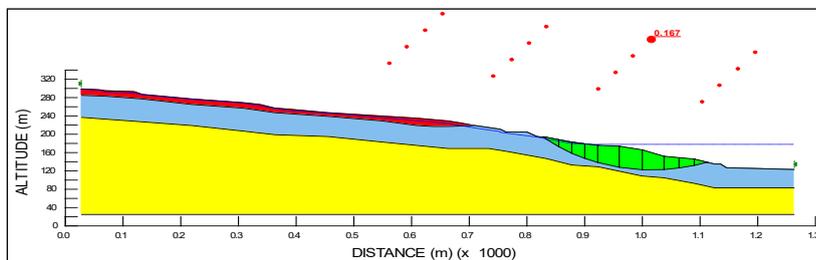
Fig. 7: Critical circle obtained according to Profile 02 (current level of the retaining wall).

- Depth of sliding = 44.44m (current level of the retaining wall).
- Depth of sliding = 44.44m (maximum level of the retaining wall).

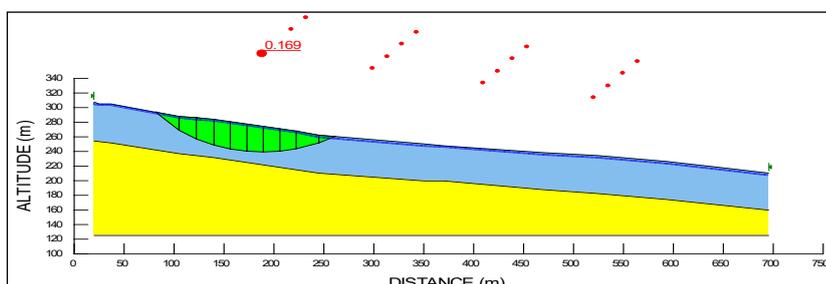
Fig. 9: Critical circle obtained according to Profile 03 (current level of the retaining wall).

- Depth of sliding = 40m (current level of the retaining wall).
