# Wooden Historic Churches of Ukrainian Descent in Poland – Current Condition and Challenges in Preserving It

Tomasz Tomaszek<sup>1</sup>

#### 3.1 Assessment of the Current State of Preservation of the Abandoned Greek Catholic Church in Miękisze Stary

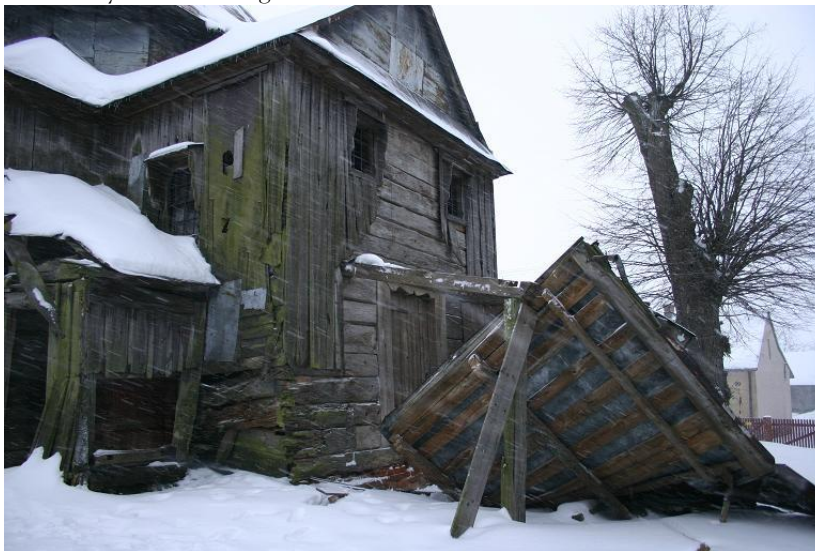
the western porch collapsed due to the weight of snow, and in the summer of 2012, local residents stored some of its damaged elements inside of the church. The church is revealing various historical and stylistic layers. The oldest part, most likely dating from the early 17th century, comprises the wall structure of presbytery. The current nave and women's vestibule were added in the late 18th century or, according to other sources, in the early 19th century, with dates given by T. Spiss as 1801 and 1811 in the publication "Szematyzmy" [6]. It is likely that the elliptical, neo-Baroque vault in the nave was added at this time, as well as the new roof with a lantern. The interior walls are decorated with illusionistic paintings, including images of the Evangelists on a tambour under the dome and angels playing instruments on the choir balustrade. In 1883, the original shingles on the roofs were replaced with metal sheet, as confirmed by the date on the lantern above the nave. During this period, the main structure of the church was enlarged to include a sacristy and two vestibules [6]. The building underwent further renovations in 1916 after damage during World War I. During this renovation, the roof was repaired, the choir was enlarged, and the boards on the exterior walls were replaced with new materials. Local accounts suggest that the renovation work was carried out by a Jew from Radymno.

In 1989, a temporary protective structure was built, and the polychrome was partially consolidated [6]. Originally the church's interior included a multi-zone, framed iconostasis, two side altars with paintings, feretory tables, a processional cross, candlesticks, liturgical vestments, and numerous smaller objects that enhanced the interior. Most of these items were transferred in 1964 and 1965 to the Voivodeship Depository of Movable Heritage in Łańcut [6], where they are currently stored in the Orthodox Art Section of the Łańcut Castle Museum [5]. Assessments conducted in 2019 revealed that the condition of the church and its wall paintings had deteriorated since the last inventory in 2006 [3]. In addition to natural causes such as moisture, fungi, and insects attacking the wood, vandalism has become a serious problem. This is clearly evident in the deterioration of the lower sections of the building, especially due to the numerous inscriptions and illustrations placed on the original colorful decorations inside the church. These inscriptions, often vulgar, are created using spray paint and various markers. Furthermore, it is assumed that the porch adjacent to the women's porch on the west side collapsed due to structural instability and the weight of accumulated snow on the roof.

**Fig. 3.** Greek-Catholic church in Miękiszy Stary – collapsed porch adjacent to the women's porch from the west; photo T. Tomaszek.

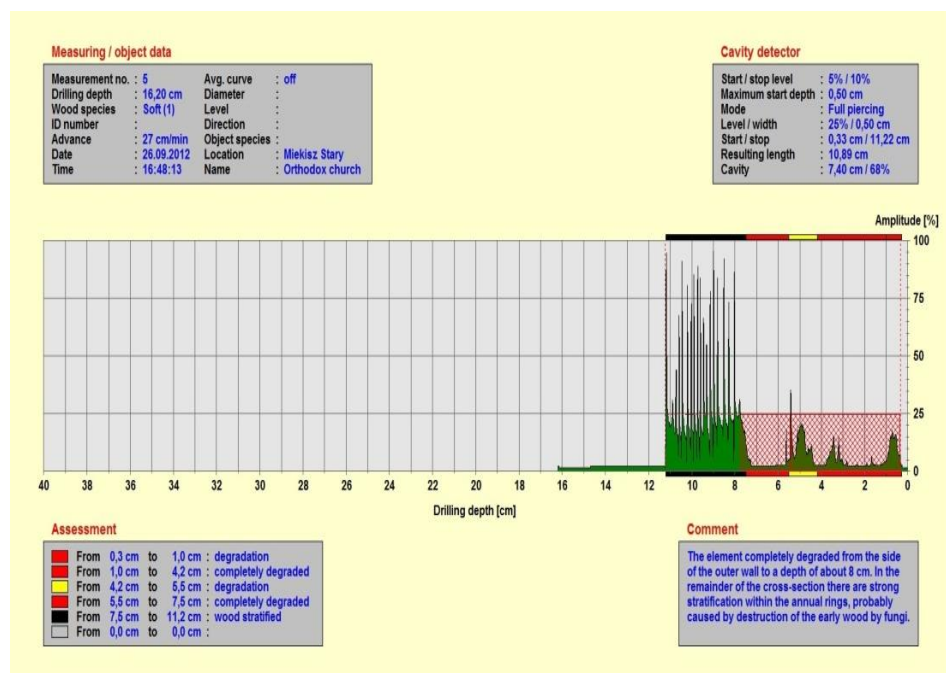
**Fig. 4.** The exemplary graph obtained during performed tests of drilling resistance of wooden elements of orthodox church in Miekiż Stary.

Tables RDM analyses reveal that conditions in the churches have significantly deteriorated, indicating that the greatest amount of damaged wooden elements is located in the lower sections of the churches. These areas are typically located approximately 1.5 meters above the ground, primarily due to the direct action of groundwater, leading to higher moisture levels. Furthermore, the research showed that the type of degradation is clearly differentiated and closely related to the location of the examined elements in relation to the cardinal directions and their specific locations within the building.

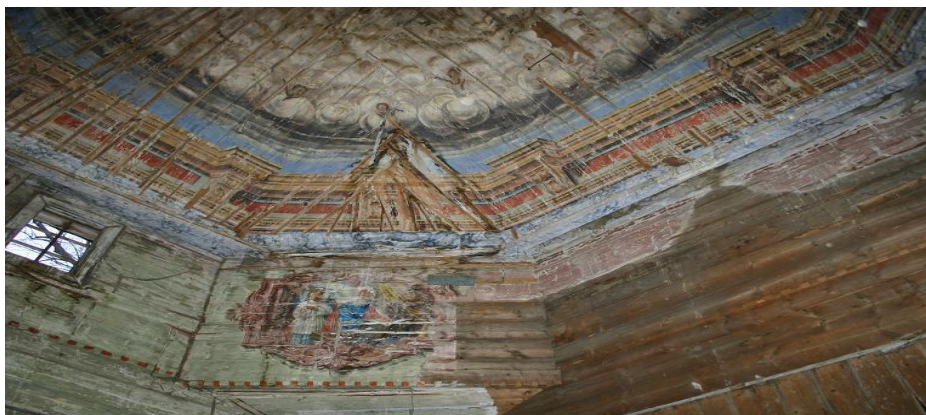
**Fig. 5.** Wall polychrome of the church in Miękisz Stary, visible illusionistic representation of the open sky placed in the dome above the architectural entablature and the figures of the Evangelists in the pendentive; photo T. Tomaszek.

At the beginning of the 20th century, the original polychrome in the sanctuary was covered with new oil decorative painting [6]. The overall condition of the interior paintings in the wooden church in Miękisz Stary is very bad and there is a risk of further deterioration. The state of preservation of various parts of the polychrome varies, primarily due to their location on the building's walls and the level of damage to some parts of the structure. There are noticeable differences in the state of preservation of the lower parts of the painting, located approximately 1.5 meters above the ground, compared to the upper parts of the polychrome. This difference results from the condition of the lower part of the building, where the wood was subjected to intense capillary moisture and other environmental factors, resulting in serious structural damage. The significant loss of wood in these areas resulted in a weakening of the brightness of the painted composition, which is particularly noticeable on the walls of the women's veranda. The degradation, which occurs due to improper adhesion of the mortar to the paint layer and the substrate, can be a result of natural wood movement caused by changes in humidity within the building.

The condition of the tempera on the polychrome decoration is very bad, requiring intensive technical and aesthetic conservation measures. The complex process of replacing damaged wooden elements or parts with new materials requires careful consideration. It is crucial to partially transfer the polychrome from elements that are to be completely removed, especially those decorated with painted figural decorations. Research indicates that the most effective conservation strategy involves transferring the paint layers to a new base that includes both the underlying primer and the outer surface of the wooden element. This approach suggests mechanically "separating" the outer surface of the painted wooden element, including the existing polychrome layer and the primer. This separation should be performed with the utmost care, ensuring that the cutting location is determined based on a thorough analysis of each element in question.
