## Management of Sediments and their Associated Nutrients in the Sanitary Area of Bovilla Lake (Albania) and the Efficiency-Effectiveness of Its Water Making Into Drinking Water

**Abstract:** Access to safe and sufficient drinking water is a fundamental public health and environmental priority. In Albania, Tirana's primary water source, Bovilla Lake, treated at the Babrru water treatment plant, faces recurrent challenges linked to watershed mismanagement. Elevated turbidity, odor, and treatment costs reflect increasing pressures on the raw water quality.

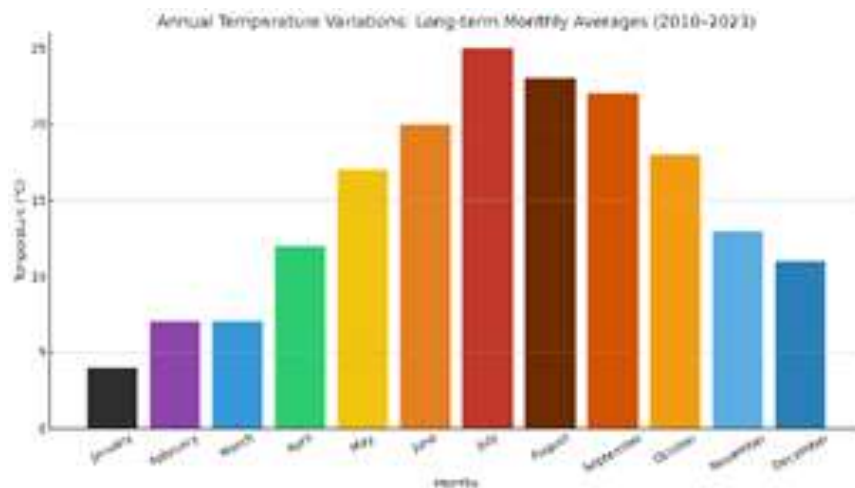
Fig. 2 Annual variations of air temperature

The climate of the Bovilla Lake catchment falls within the sub-hilly Mediterranean climatic zone, with annual precipitation patterns illustrated in Figure 2. The average annual rainfall ranges from 1,200 to 1,300 mm/year (1 mm of rainfall in a pluviometer is equivalent to one liter of water per square meter). Temperature trends are shown in Figure 3. These data were obtained from source [10].

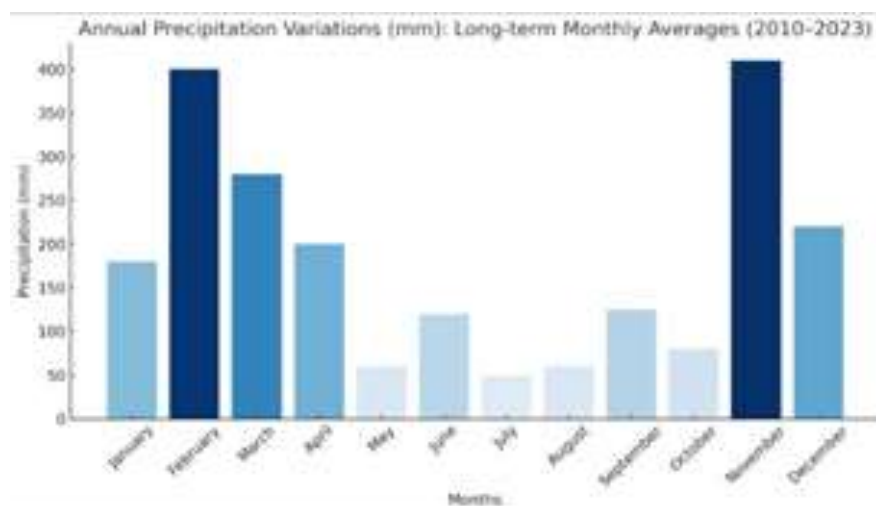
Fig. 3 Annual variations in precipitation

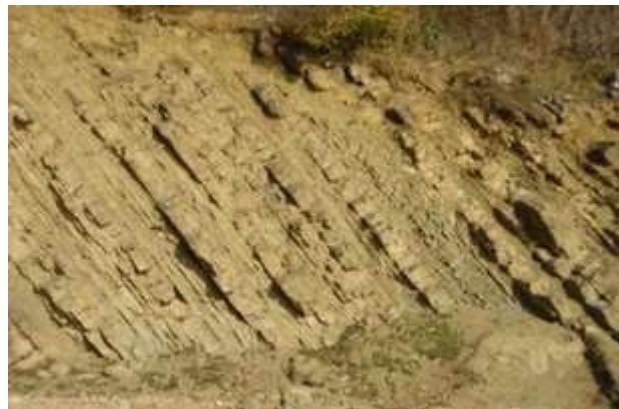
Fig. 5 Marl package and flysch formation (photo by E. Kiri)

Above the carbonate formation lie transitional marls and flysch formations. These consist of a rhythmic interbedding of clay and sandstone, forming a substantial overlying cover characterized by significant thickness. The presence of this layer has made it possible to construct the Bovilla Reservoir, as it prevents the reservoir's waters from diffusing into the underlying carbonate formation [12].

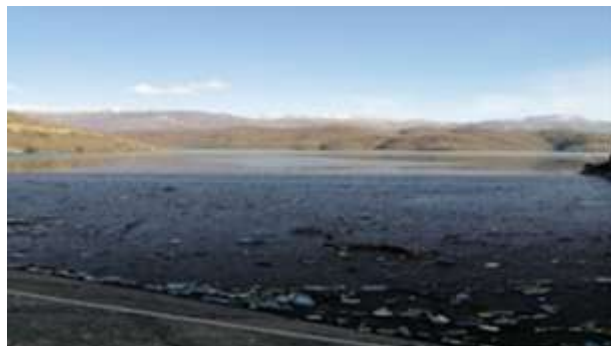
**Fig. 7** Plastic waste in the Bovilla Lake (Photo by M. Hoxhaj, 2024)

*Pollution During High-Flow Periods:* During high-flow conditions or flood events, the input of waste into the lake increases substantially.

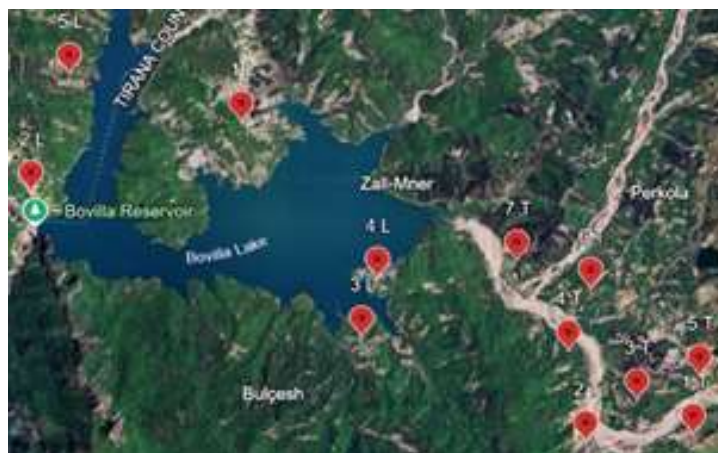
**Fig. 8** Distribution of surfaces vulnerable to erosion in the sanitary area

The following areas have been identified as the most vulnerable to erosion within the sanitary protection zone, such as: surfaces damaged vegetation (SDV), cultivated area (CA). These surfaces were categorized into two groups:

1. Surfaces where sediments flow directly into the lake
2. Surfaces within the sub-basin of the Tërkuza River, where sediments are transported indirectly via the river.

Field observations and satellite images have enabled the determination of these areas.

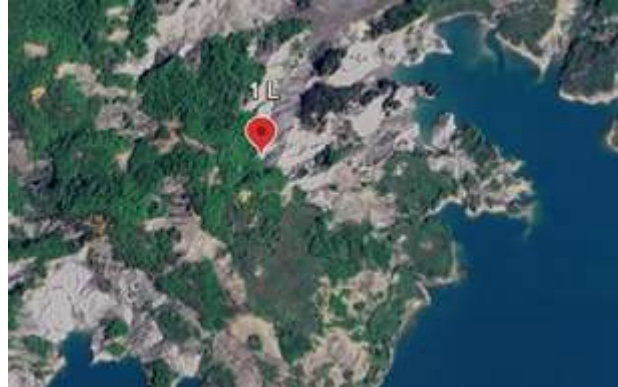
**Fig. 10** Satellite image of Surface 1L

(LS) Factor – Topographic Factor: The assessment of this factor was carried out by measuring the slope gradients and lengths. In Fig. 10, is a Landsat–Copernicus satellite image for 1L, in the same manner are assessed for other surfaces, listed in Table I.

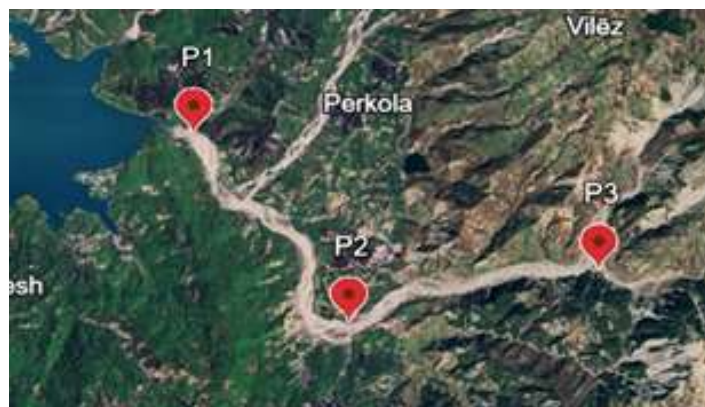
**Fig. 11** Sampling points along the Tërkuza River

Physico-chemical water analyses were conducted at three points along the Tërkuza tributary:

P1 – 320 m.a.s.l., N 41° 26' 43", E 19° 54' 44"

P2 – 367 m absL, N 41° 25' 43", E 19° 55' 44"

P3 – 400 m.a.s.l, N 41° 26' 00", E 19° 57' 20"

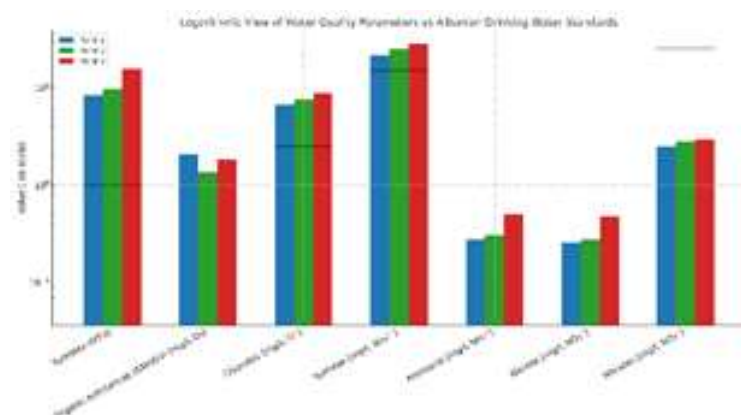
**Fig. 12** Graphical presentation of water analysis results from the Tërkuza River (April'2024)

Parameter	Point 1	Point 2	Point 3	Al. Standard D.W
Turbidity, NTU	8.3	9.7	15.6	1
Organic substances (KMnO <sub>4</sub> ) mg/L O <sub>2</sub>	2.08	1.35	1.85	
Chlorides, mg/L Cl <sup>-</sup>	6.73	7.55	8.79	2.5
Sulfates, mg/L SO <sub>4</sub> <sup>2-</sup>	21.45	25.15	28.30	15
Ammonia, mg/L NH <sub>4</sub> <sup>+</sup>	0.28	0.31	0.5	0.05
Nitrites, mg/L NO <sub>2</sub> <sup>-</sup>	0.26	0.28	0.48	0.05
Nitrates mg/L NO <sub>3</sub> <sup>-</sup>	2.5	2.8	2.96	25
Total coliforms CFU/100mL	550	392	496	50
Faecal coliforms CFU/100mL	480	989	1235	20

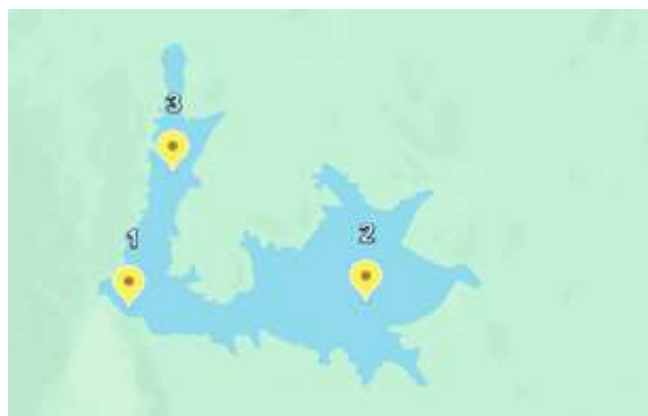
**Fig. 13** Monitoring stations in Bovilla Lake

The waters of Bovilla Lake were analysed at three monitoring stations, as shown in the figure below, during the period from May 2023 to March 2024. In the lake, samples were taken from the water layer extracted by the Water Treatment Plant for the production of drinking water. The number and positioning of the monitoring stations in the lake were determined based on the lake's shape and surface area.

- Station 1: 41° 26' 44", E 19° 52' 9.4", depth 48 m
- Station 2: N 41° 26' 36.3", Longitude E 19° 53' 7.6"
- Station 3: N 41° 27' 28.3", Longitude E 19° 52' 34.0"

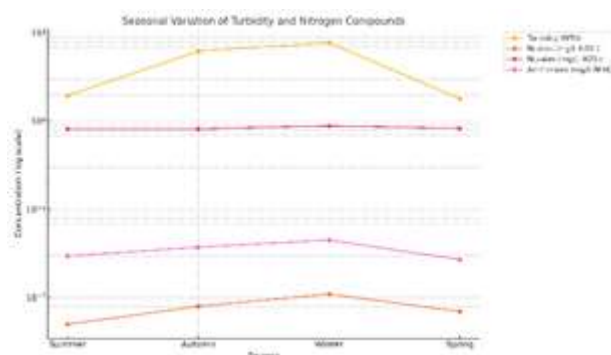
**Fig. 14** Seasonal dynamics of nitrogen compounds and turbidity in Lake Bovilla (2023-2024)

In general, it is observed that the average values of chemical indicators reach their maximum during the winter season. This pattern is also evident for turbidity and sediment load, both of which show the highest seasonal averages in winter. Further studies are necessary to clarify these correlations.
