Self-Cleaning Shower for Pickling lines

Abstract

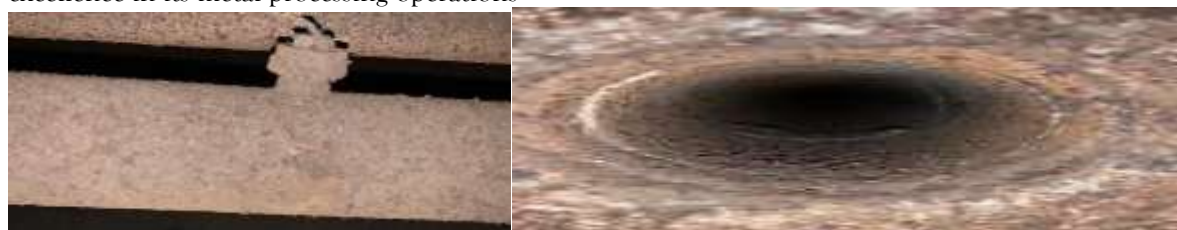
Fig 1: Effect of Corrosive Work Environment on Conventional Systems

Despite their importance, conventional rinsing systems face significant operational challenges. They operate in highly corrosive environments, making them prone to clogging due to the accumulation of particulates and residual chemicals. This clogging not only disrupts the rinsing process but also necessitates frequent maintenance, resulting in considerable downtime. Such interruptions can severely impact production efficiency, leading to increased operational costs and delays in delivery schedules.

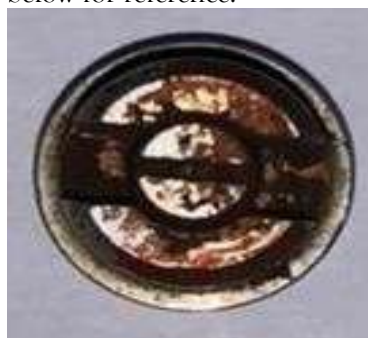
Primary type of clogging residual observed in the nozzle is of red colored amorphous powder. It is suspected to be rust generated by corrosion of pipe internally by HCL. Severe rusting residual can be observed inside of the existing nozzles.

Hence, root cause of clogging can be estimated due to rusting residual of pipe by HCL. Photos attached below for reference.

Fig 3: Clogged Nozzles

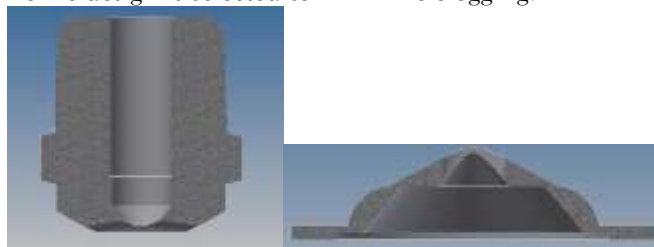
Fig 4: Old Nozzle vs New Nozzle C/s

As evident in fig.4 conventional nozzles have narrow passageways & hence are subjected to clogging due to material build up. To avoid clogging due to material build up new nozzle design is selected where convex curves of the nozzles is in contact with the water & hence any debris is not allowed to form between the passageways.

Earlier nozzles opening cross-section was observed to be narrow & prone to clogging. New clog-free type nozzle design is selected to minimize clogging.

Extensive test were performed to ensure both nozzles share same flowrate for given pressure.
