# Kinematic Analysis of Slopes in the Western and Eastern Walls of the Karowe Open Pit, Botswana

## ABSTRACT

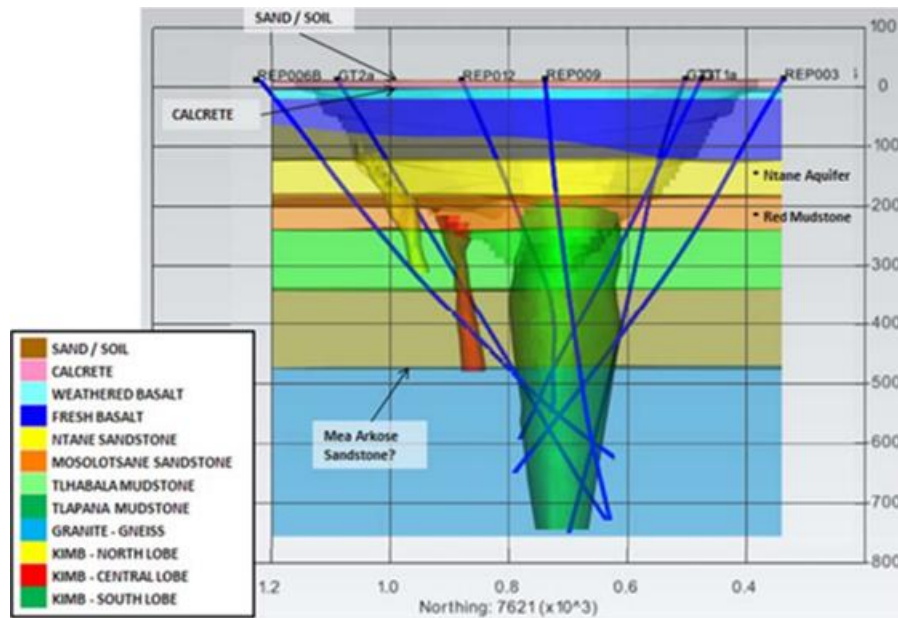
Fig.5: 3 D Country Rock Geological Model

According to Karowe Mineral Resource Update (2018). & Barnett, (2007) developed the current structural model using data gathered from borehole core study conducted in 2007 for project-related objectives, with specific emphasis on characterizing fracture zones. Figure 4 displays this model, though it has not yet been confirmed through in-pit investigations.

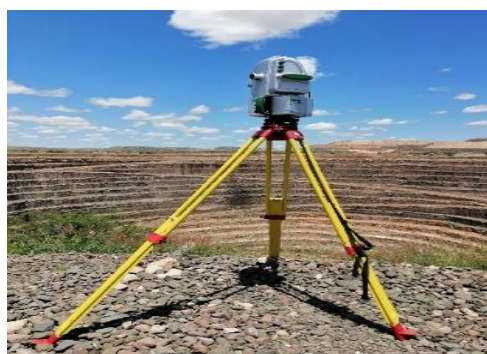
Fig.6 : Maptek Laser Scanner

Discontinuity mapping within the mine primarily utilized a Maptek 3D Laser Scanner (Fig.6). Initially, a comprehensive orientation scan was conducted using ground control points (GCPs) to encompass the targeted mapping areas, essentially covering the entire pit. The data collected by the tablet was stored and later downloaded for transfer and processing using Maptek software. This software was employed to clean and geo-reference the scan data, aligning it geographically with its original capture position in the pit. Structures within the scans were digitized and either saved or exported for utilization in other third-party applications.

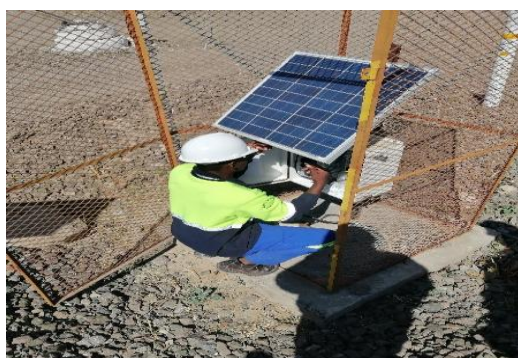
Fig. 7: A Piezometer Station

The mine utilized vibrating wire piezometers (Fig.7) installed at specific depths within drilled boreholes in the ground to accurately measure groundwater pressures within subsurface formations. These piezometers were equipped with sensors designed to measure water pressure. The signal from the vibrating wire sensor was transmitted to a signal conditioning unit, which amplified and processed the signal to accurately measure the resonant frequency shift caused by the pressure change. Subsequently, the processed signal was sent to a remote data logging system where it was recorded at regular intervals. The recorded data was later retrieved and interpreted to determine variations in pore water pressure over time.

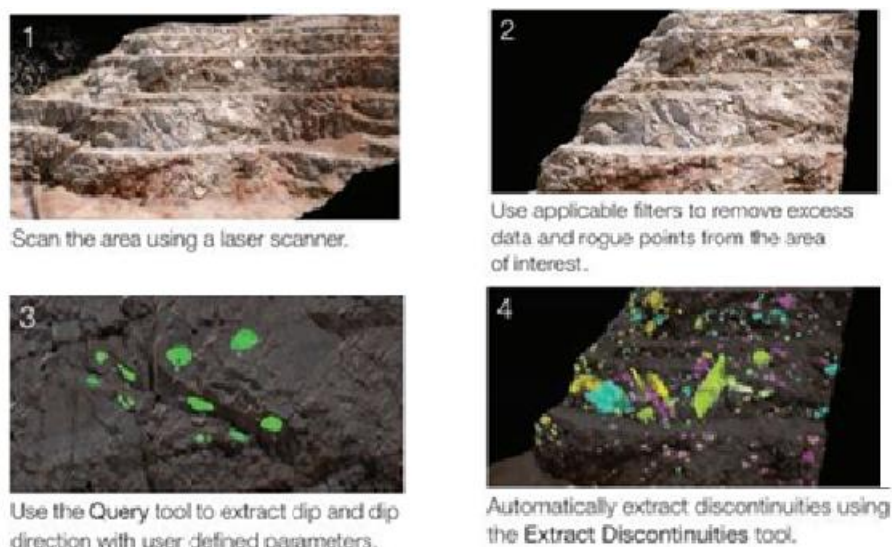
**Fig.10 :Maptek Discontinuity Process**

Discontinuity data from the Maptek 3D laser scanner was cleaned to a higher resolution using the Maptek 3D Point Studio software at the mine. The software automatically detected and classified the discontinuities, and they were inspected by visually inspecting a 3D-generated model of the pit. Orientation data was analysed to give the strike, dip, and dip direction of discontinuities to understand geological structures and their spatial distribution. Statistical parameters such as spacing, persistence, roughness, and clustering of discontinuities were calculated within the software to characterize the rock mass behavior. The figure 10 below show a brief description of the process undertaken:

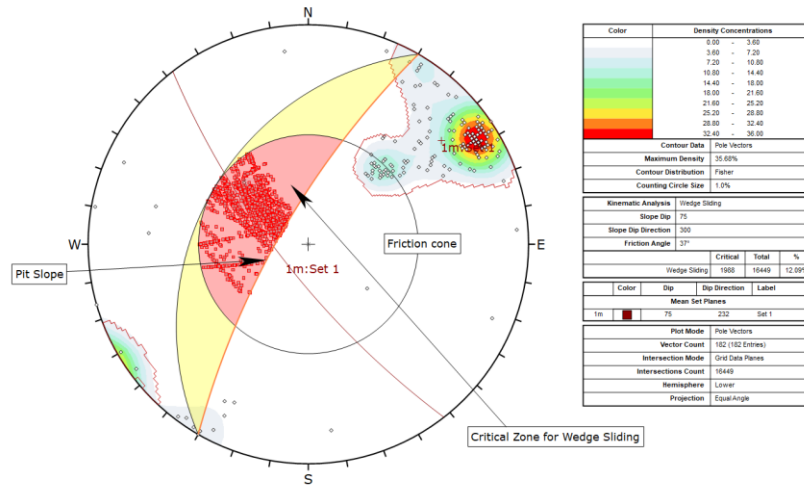
**Fig. 15: A Sliding Mechanism**

The northwestern sector of the Karowe pit reveals a potential for wedge sliding failure modes along the slope, as evidenced by critical joint intersections exceeding 12.09%, indicating a heightened risk of wedge failures. The Primary Critical Zone for Wedge Sliding is represented by a crescent-shaped area within the plane friction cone of the slope plane (highlighted in red in Figure 15). Intersections falling within this zone denote wedges that meet both frictional and kinematic conditions for sliding. The Secondary Critical Zone (highlighted in yellow in Figure 15) lies between the slope plane and a plane (great circle) inclined at the friction angle. Critical intersections within these zones signify wedges that slide along a single joint plane. In this area, the intersections are inclined at angles less than the friction angle, but sliding is likely to occur on a joint plane with a dip vector greater than the friction angle.

Kinematic analysis	Wedge Sliding		
Pit Slope dip	75		
Slope dip direction	300		
Friction angle	37		
	Critical	Total	Percentage
Wedge Sliding	1988	16449	12.09%

Kinematic Analysis indicates Direct toppling failure (12.43%) and Wedge failure mode (12.09%) being the most prominent across the northwestern and southeastern regions of the pit.
