# Wooden Historic Churches of Ukrainian Descent in Poland – Current Condition and Challenges in Preserving It

Tomasz Tomaszek<sup>1</sup>

#### 3.1 Assessment of the Current State of Preservation of the Abandoned Greek Catholic Church in Miękisze Stary

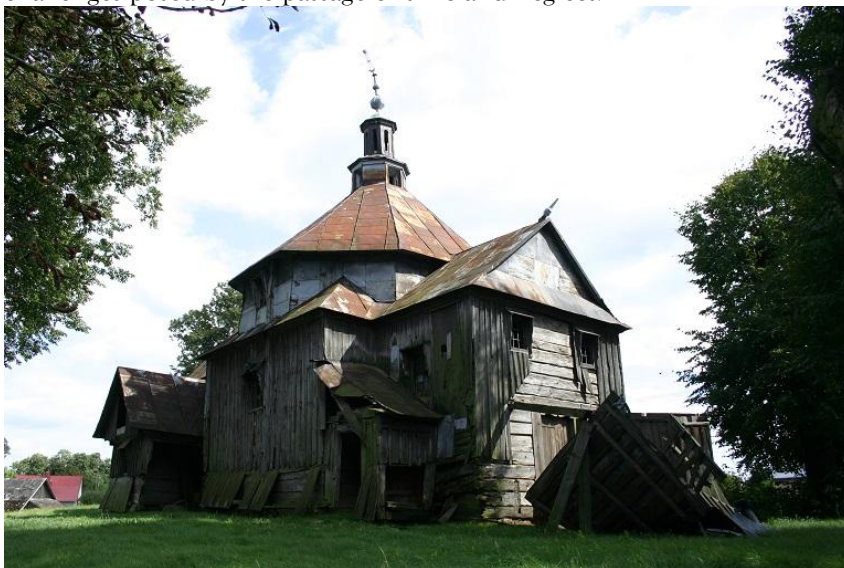
Fig. 2. Greek-Catholic church in Miękiż Stary; photo T. Tomaszek

The Greek Catholic Church in Miękiż Stary was built of wooden beams and consists of three main sections: the presbytery, the nave, and the women's gallery (vestibule). To the north of the three walls enclosing the altar is the sacristy, which is made of wood and adjoins the frame building. Additionally, on the western and northern sides, there are frame porches near the women's gallery. In February 2010,

the western porch collapsed due to the weight of snow, and in the summer of 2012, local residents stored some of its damaged elements inside of the church. The church is revealing various historical and stylistic layers. The oldest part, most likely dating from the early 17th century, comprises the wall structure of presbytery. The current nave and women's vestibule were added in the late 18th century or, according to other sources, in the early 19th century, with dates given by T. Spiss as 1801 and 1811 in the publication "Szematyzmy" [6]. It is likely that the elliptical, neo-Baroque vault in the nave was added at this time, as well as the new roof with a lantern. The interior walls are decorated with illusionistic paintings, including images of the Evangelists on a tambour under the dome and angels playing instruments on the choir balustrade. In 1883, the original shingles on the roofs were replaced with metal sheet, as confirmed by the date on the lantern above the nave. During this period, the main structure of the church was enlarged to include a sacristy and two vestibules [6]. The building underwent further renovations in 1916 after damage during World War I. During this renovation, the roof was repaired, the choir was enlarged, and the boards on the exterior walls were replaced with new materials. Local accounts suggest that the renovation work was carried out by a Jew from Radymno.
